# ECHO LAKE PARK

## Park Assessment

August 28, 2016 (rev. March 2017)

In the past, the City of Fort Worth has been asked to assume maintenance and management of Echo Lake Park from Tarrant County. The purpose of this report is to provide an update on the letter issued on May 19, 2003 to City Manager Gary Jackson.

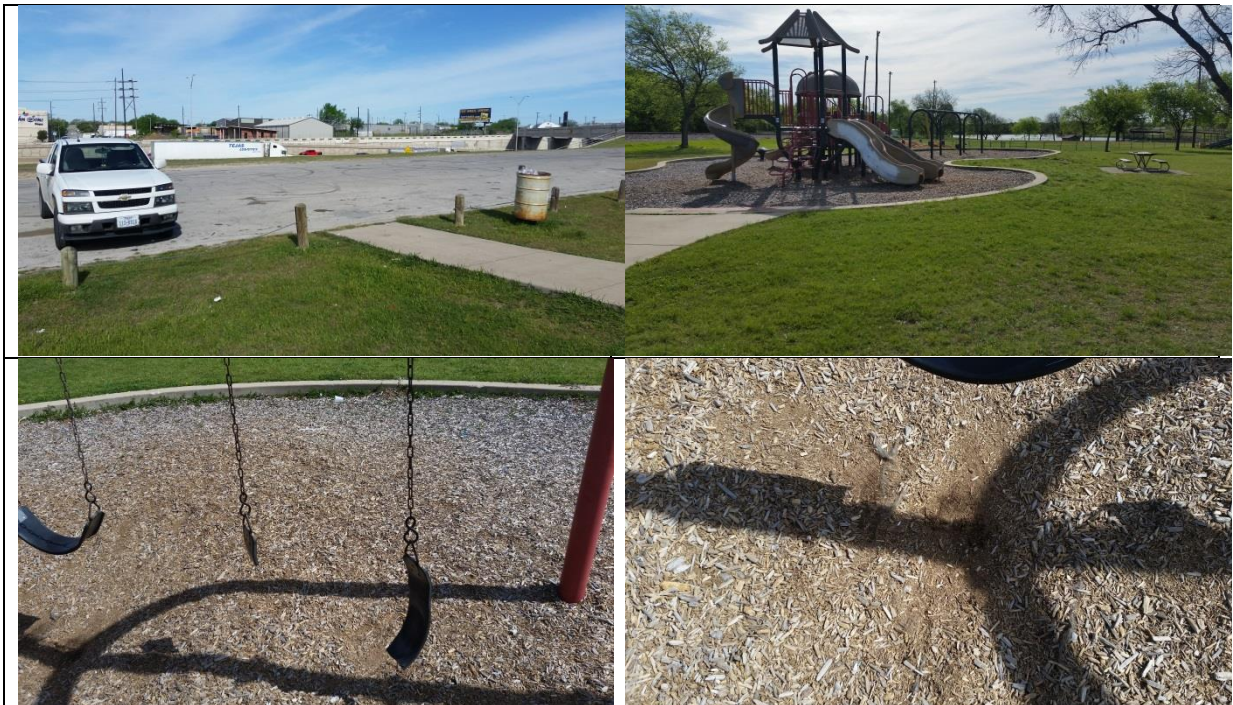
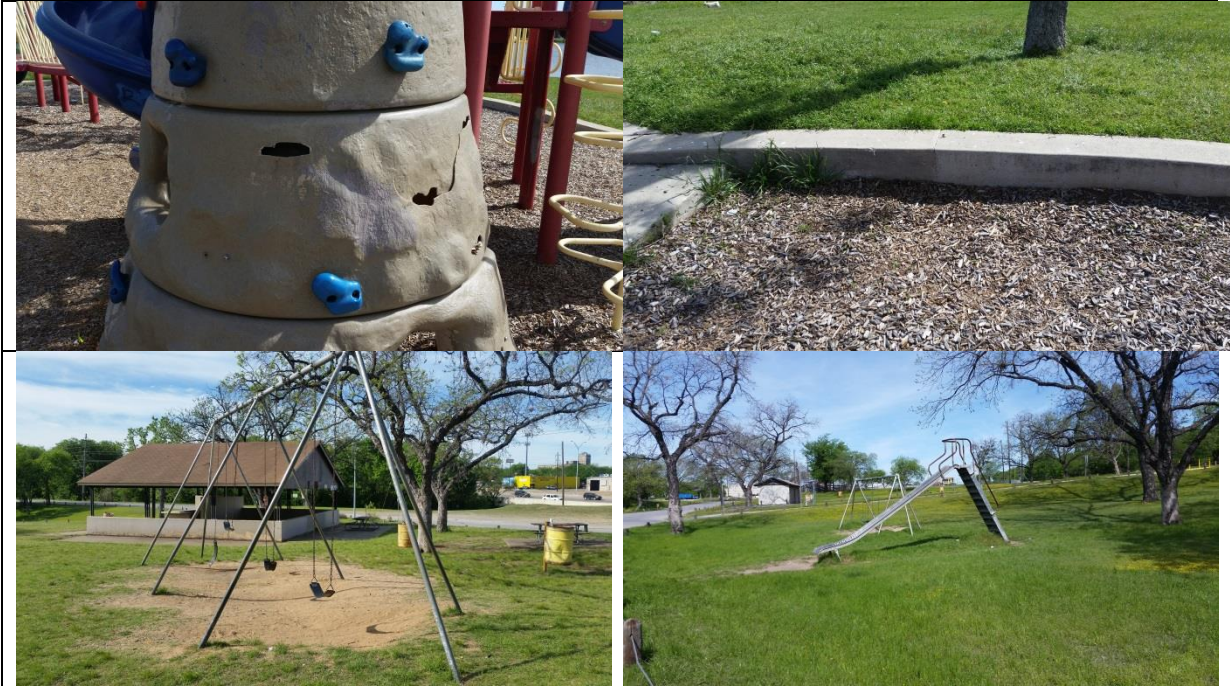
1. PLAYGROUNDS: Two approved CFW playground prototypes were installed since 2004. Both have an accessible walk to the playground. However, there is no HC parking available. Playground prototype equipment has been damaged and not replaced. It appears that the rubber mats were removed from under found at any of the slides or swings. No maintenance has been performed on the engineer wood fiber surfacing and grass growing inside the playground. The fiber is also low at both locations. Multiple standalone playground equipment pieces were found in the park with no safety surfacing or handicap accessibility. Standalone equipment needs to be removed.

Estimated cost \$35,400.00 (removal of standalone equipment, playground replacement parts, wood fiber surfacing, 12 wear mats).

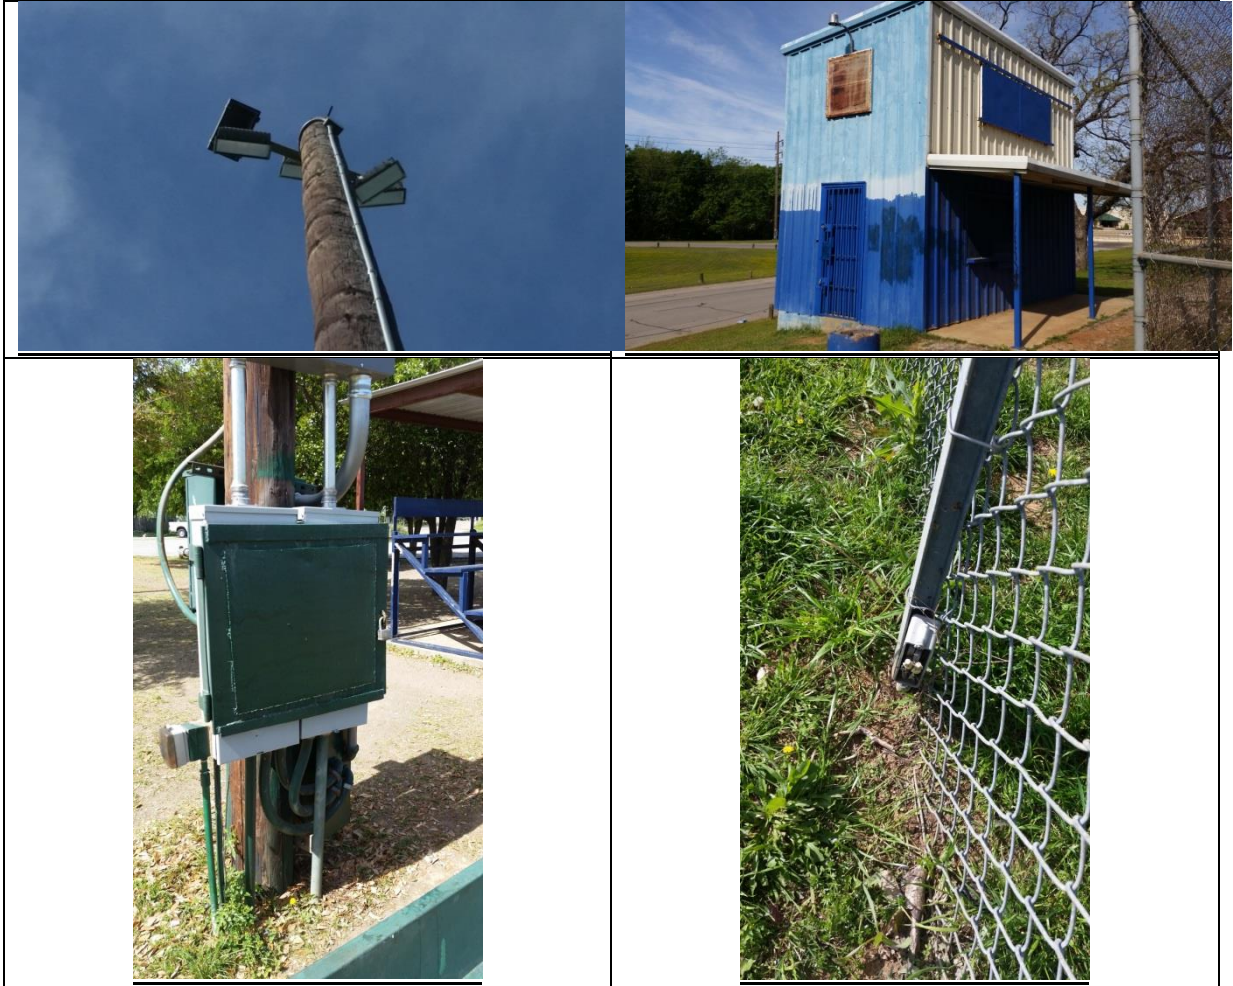
2. **BALLFIELD LIGHTING:** Current lighting does not meet PARD's standards for ballfield illumination. Overall site electrical components, including ballfield lighting, were inspected by the City Planning & Development Department in February 2017 and found to be satisfactory – after some recent conduit improvements and securing of panel boxes. Wood poles and fixtures are not PARD standards. The existing electrical panel may not have the capacity to add lights to increase the illumination to PARD's standards for ballfield illumination. The existing power source box next to the west ballfield is not secured to the ground. The footing is made out of plastic and foam and has no anchor to the ground. Open electrical boxes were found next to the fence at the far west ballfield.

Estimated cost \$500,000.00 (Demolition and installation of 2 ballfield lighting systems).

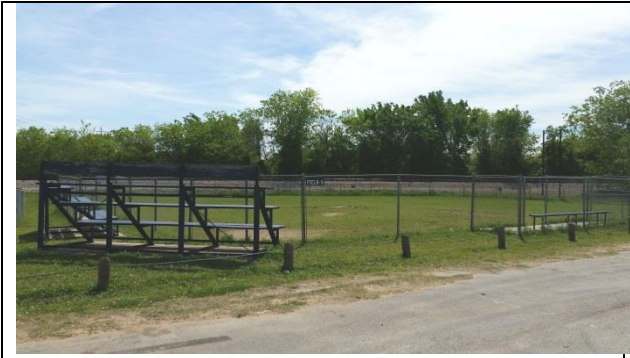
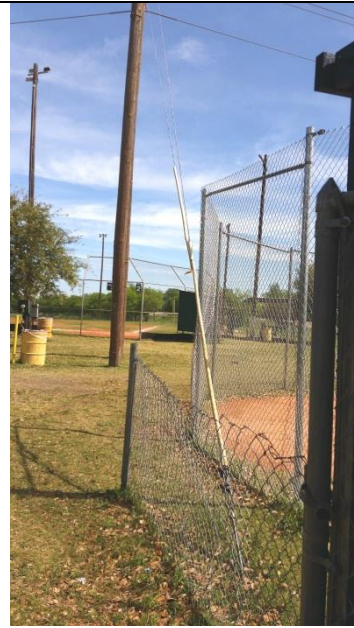
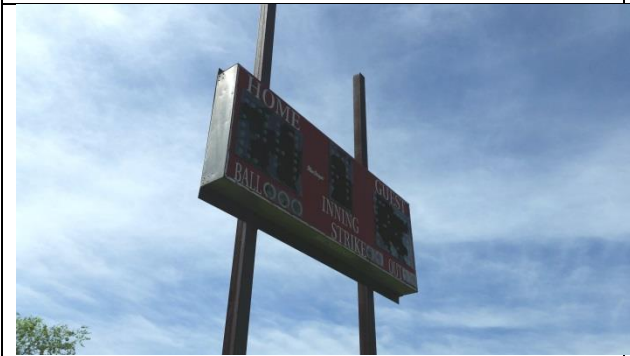
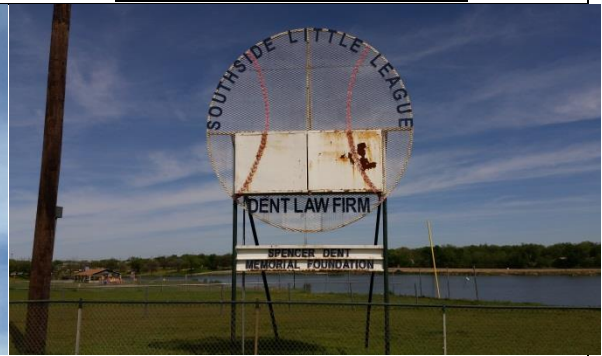
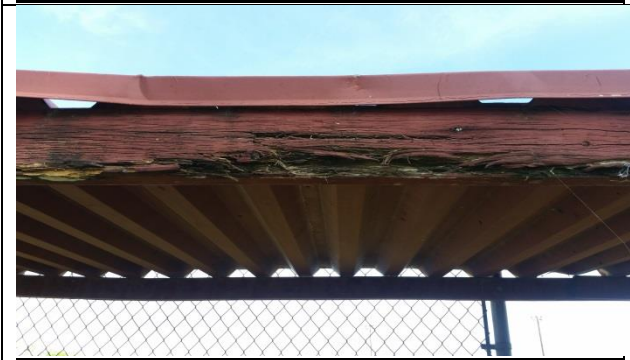
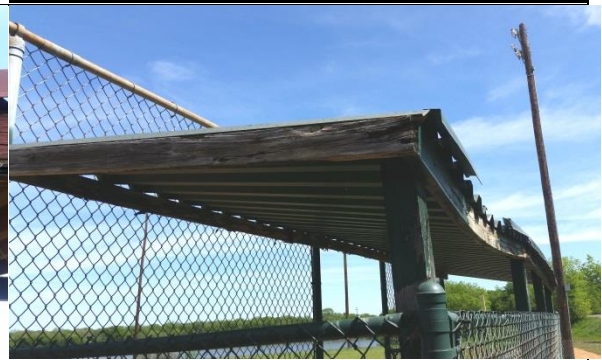
3. BALLFIELDS: Echo Lake Park has five ballfields. The four ballfields on the south side of the park are in poor condition. These fields are very small, close together, difficult to maintain, and they are not handicap accessible. Additionally, power line supporting poles are too close to the ballfield and are a hazard to the players. Only two of four scoreboards are functional (east and west). The remaining scoreboards are either vandalized or rusted. All wood frames in the dugouts need to be replaced or demolished. The entire ballfield fence needs to be upgraded or replaced. The foul poles need to be repaired or replaced. Drinking fountains are not PARD standard and they need to be replaced or removed from the site. Due to the amount of damage and danger surrounding all the ballfields they either need to be demolished or re-configured into non-competition fields. Bleachers do not meet ADA requirements. There is no clear accessible route to any of the bleachers.

Some of the existing frames are rusting or bent. The bleachers need to be removed and replaced.

Estimated cost: \$667,042.00 (Fencing 5 fields, rebuilt dugout at 5 fields, 2 Drinking Fountain, 2 Scoreboards, 2 irrigated fields, Concrete Sidewalk, 2 Competition fields with 3 practice fields, 12 Bleachers)

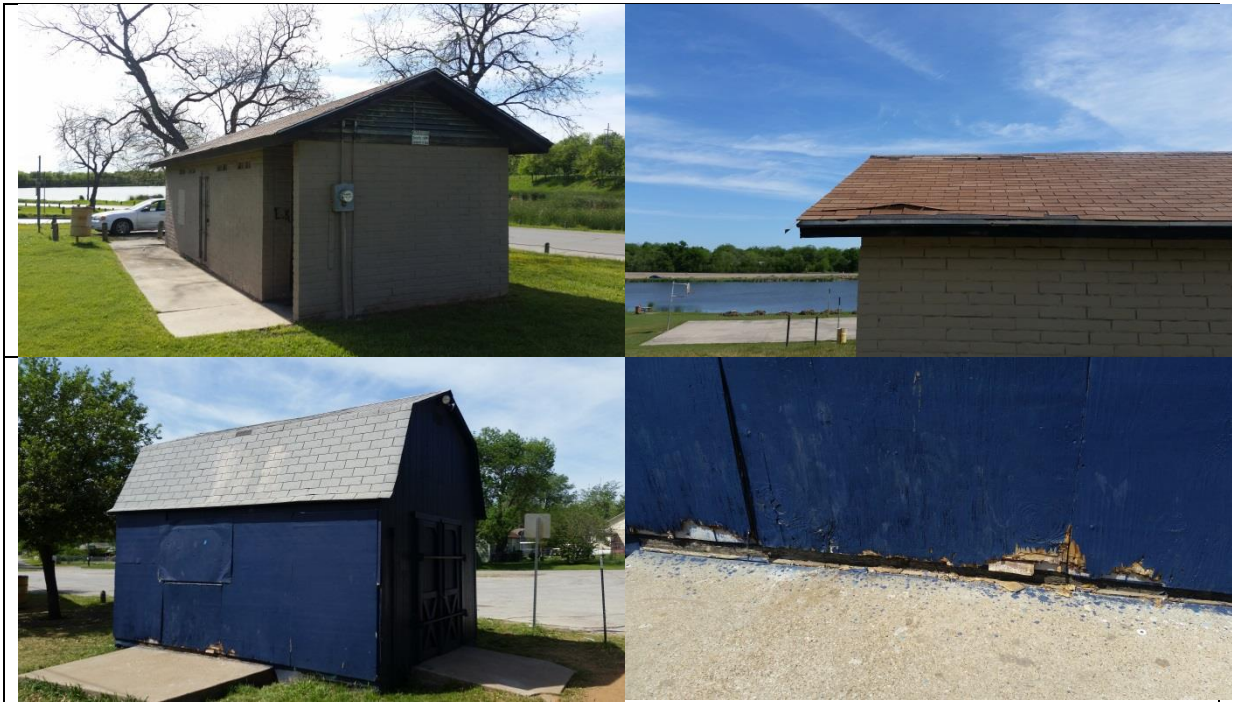
4. **RESTROOM AND STORAGE BUILDINGS:** All buildings must be inspected by Property Management. Access to the inside of the roof and utilities was not available. No doors were found at the entrance for winterization. Restroom buildings must be removed due to damaged roof, trip hazards, ADA accessibility issues, pest damage and poor condition of fixtures. Future

restroom facilities to consist of port-a-lets inside decorative enclosures. The storage building next to the ballfields requires miscellaneous repairs including siding replacement and roof replacement.

Estimate cost: \$100,000; \$75,000 to install two new restroom enclosures with port-a-lets (1 ea.) and \$25,000 to demo two bathroom buildings and the storage building.

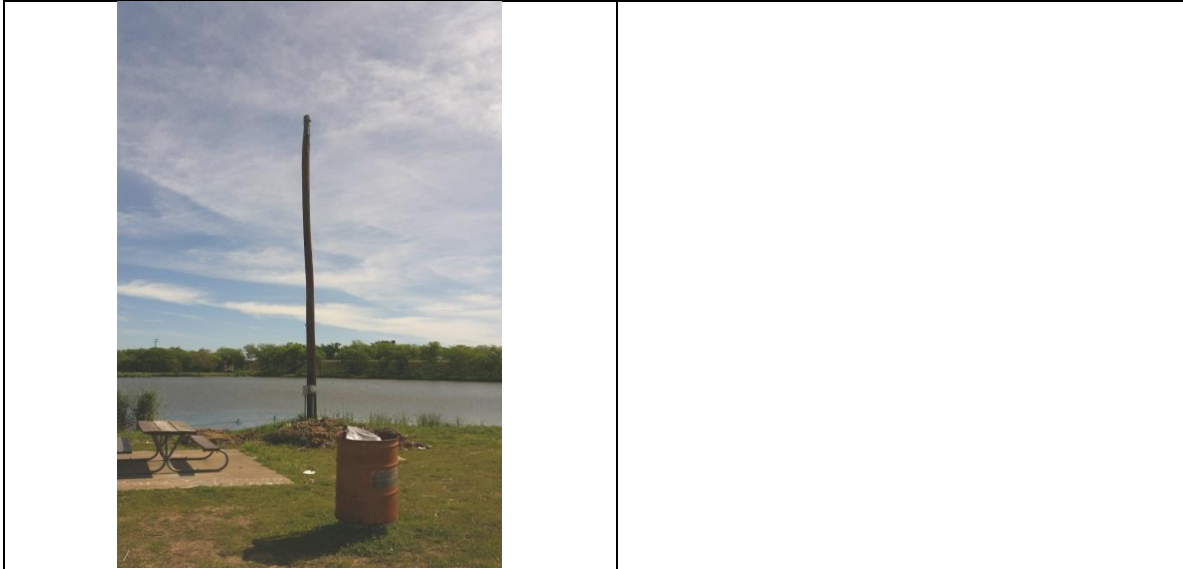
5. SECURITY LIGHTING: Most of the existing light poles are missing a fixture or need bulb replacement. There is no security lighting located at the parking lots, basketball court or the playground equipment.

Estimated cost \$286,000.00 (26 lights).

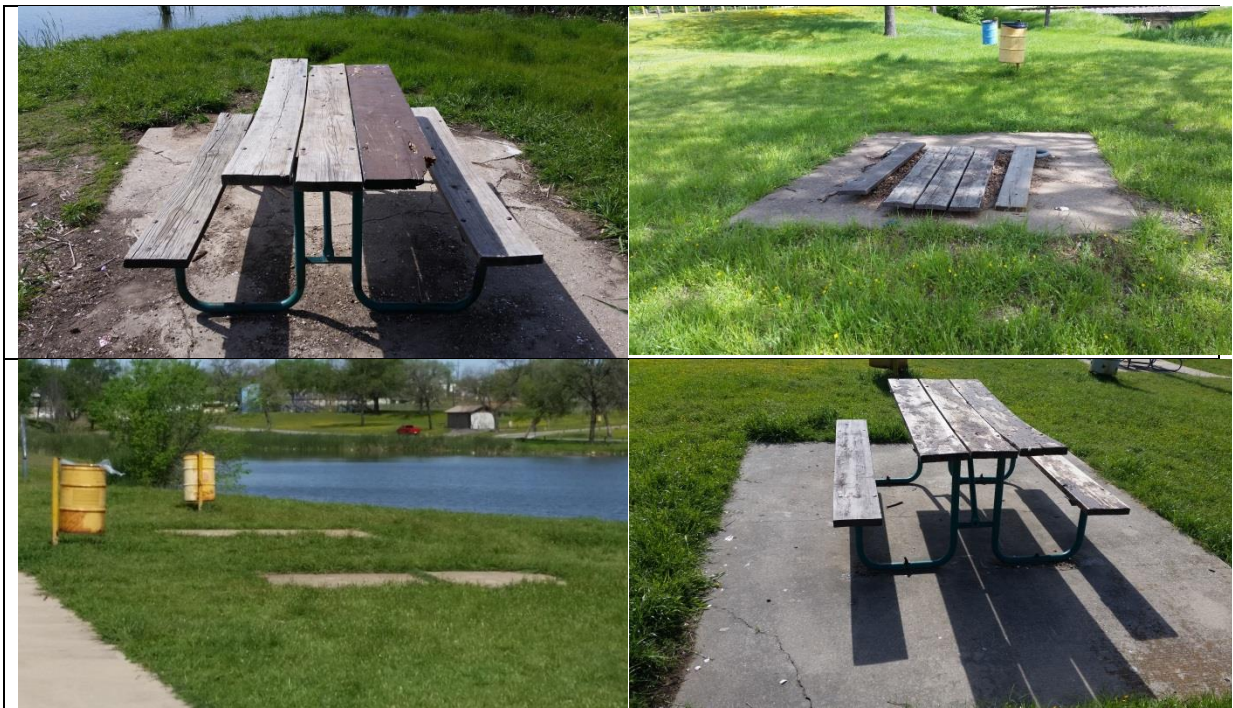
6. PICNIC TABLES: There are 34 existing picnic tables and concrete pads. None of the tables meet the ADA requirements for accessibility. All existing picnic tables need to be replaced due to poor condition. Approximately half (17) of the concrete pads must be replaced.

Estimate cost \$56,250.00 (25 standard picnic tables, 9 HC tables and 17 concrete pads)

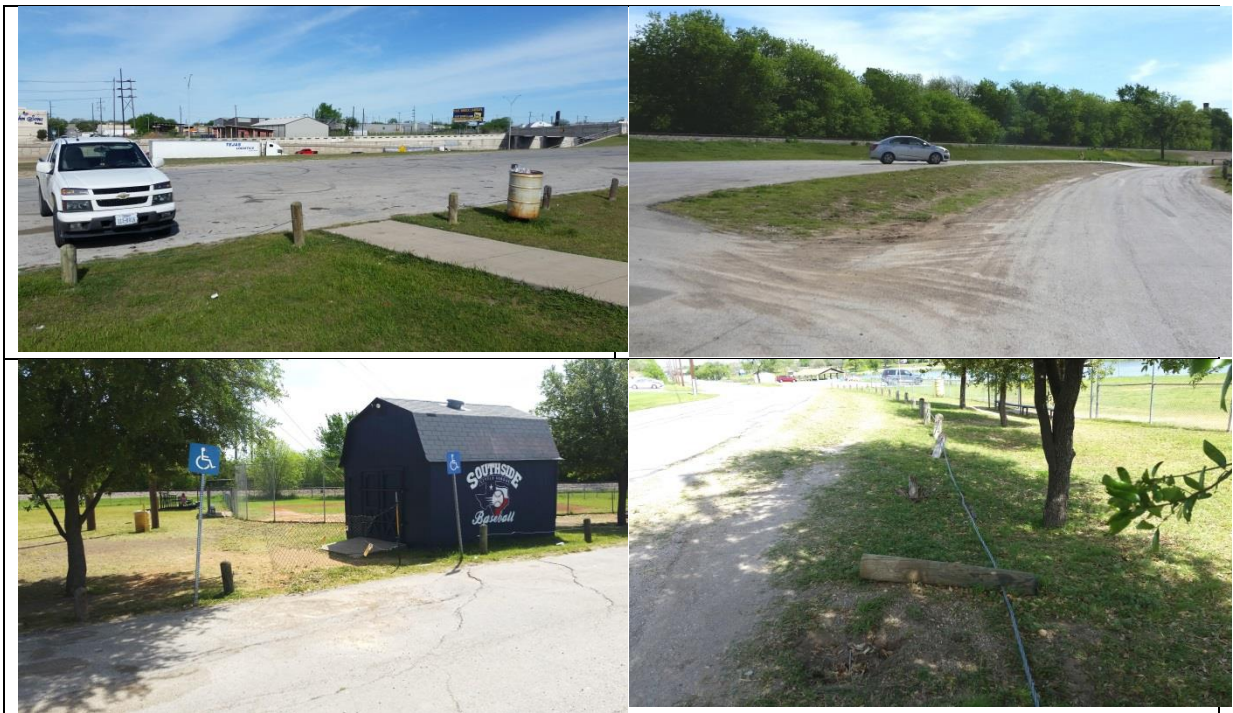
7. ROADS: Roads appear to be in good shape. The parking lots have no accessible parking spaces, no stripping or handicap signage that meets Texas Accessibility Standards. The east parking lot next to the ballfield has two handicap signs that are holding an unsafe chain link fence that needs to be removed.

Estimated cost: \$27,500.00 (Striping and signage for 9 accessible parking spaces)

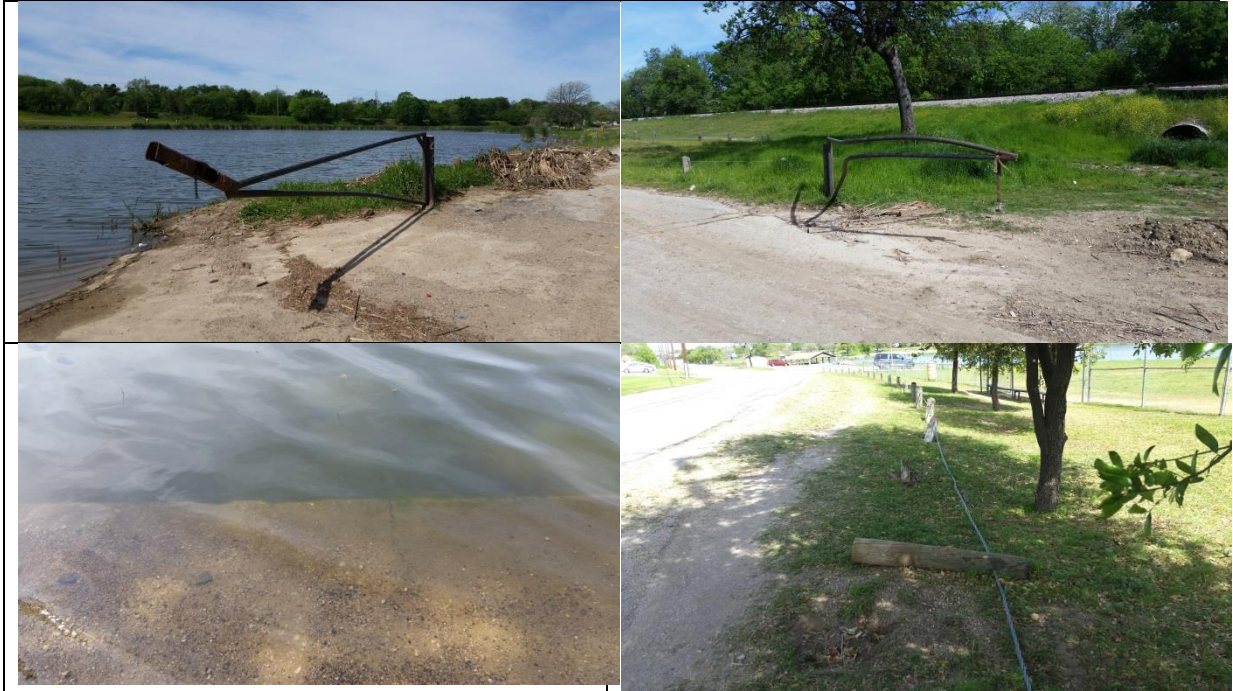
8. GATE & GUARDRAIL: The vehicular gate to the boat ramp has been damaged and needs to be replaced. A guard rail must be installed in the boat ramp area to mitigate the steep drop off from the edge.

Estimate cost \$43,820.00 (replacement existing gate, guard rail and post & cable).

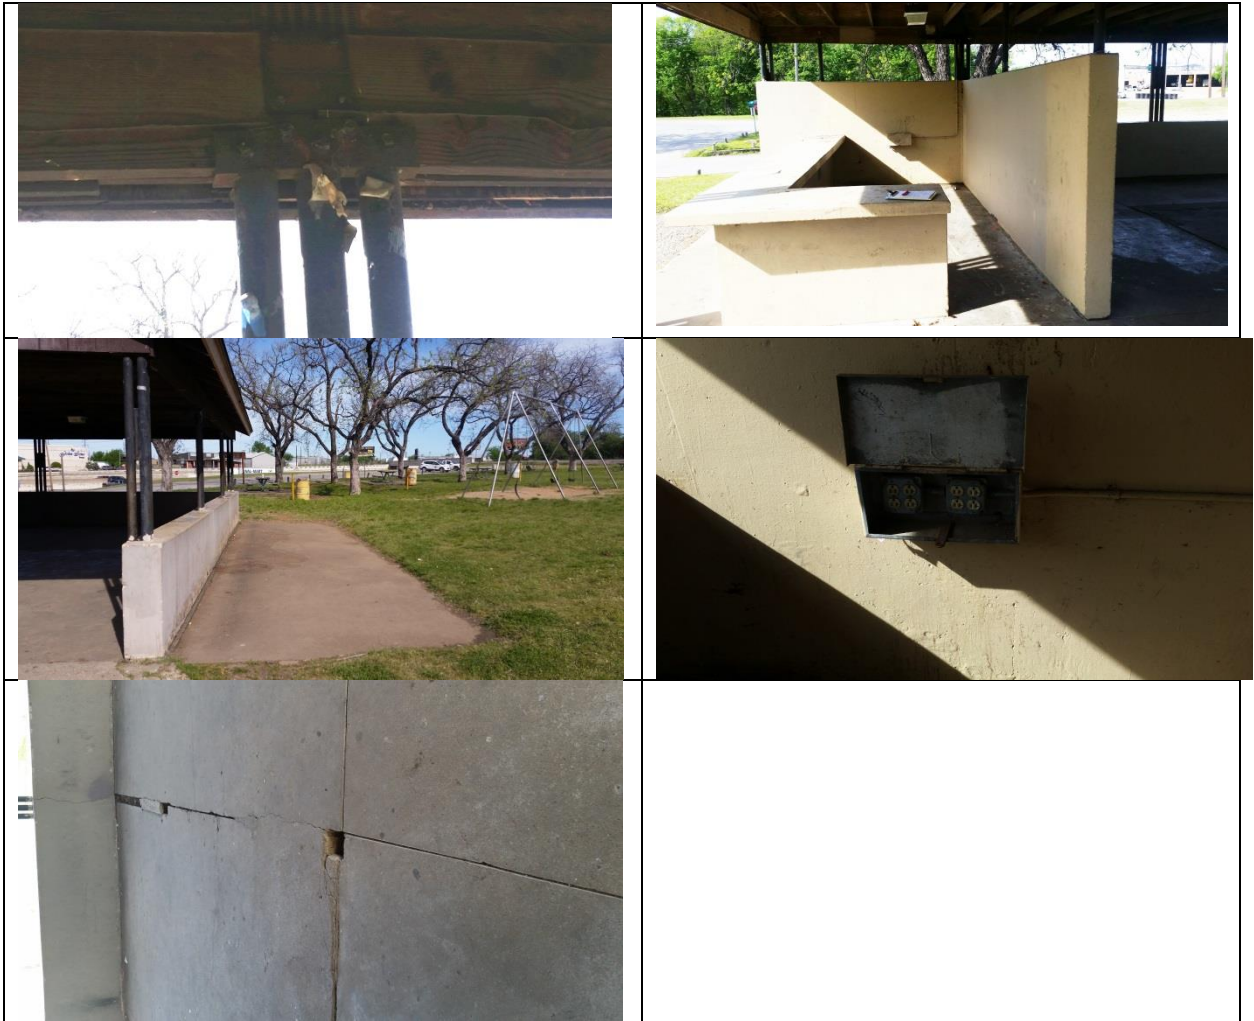
West Shelter

9. **SHELTERS:** Shelter on the west end of the park is in poor condition. The concrete floor has multiple cracked areas and is missing a pier. The roof is in poor condition and requires replacement of several framing members. The electrical wiring must be removed and replaced. There is no accessible route to the shelter.

In February 2017 the City Planning & Development Department assessed the condition of both shelters and recommended demolition of both due to structural stability issues, accessibility issues, and possible public health issues.

Estimate cost \$351,256.00 (Demo both structures, install a 24'X24' shelter on west side and a large group shelter on the east side – 40'X80')

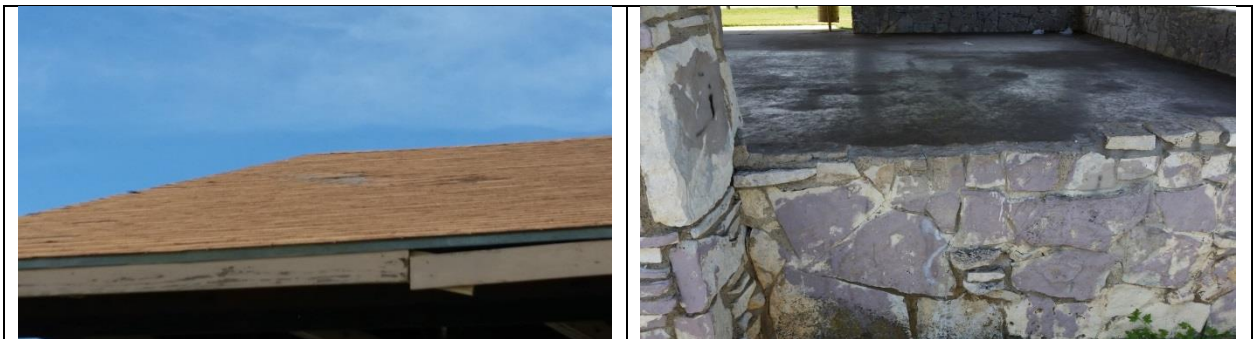
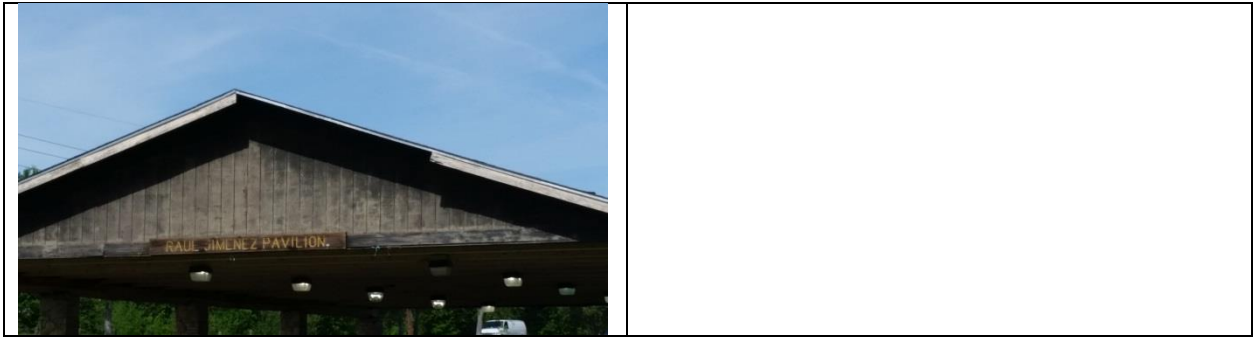
East Shelter (Raul Jimenez Pavilion)

Shelter to the east is also in poor condition. The concrete floor is in poor condition with several cracks. The shingles show some hail damage and the roof is in poor condition; support members show signs of rot, various degrees of degradation. Structure contains stone columns at all support columns and a 4 foot retaining wall; all of which have significant cracks and would have to be completely re-constructed.

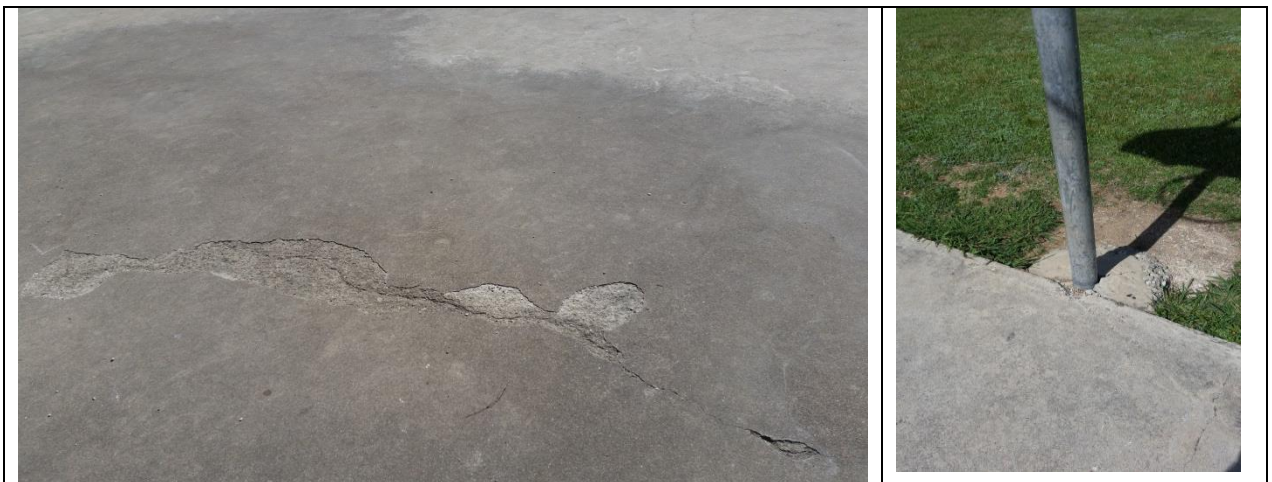
10. BASKETBALL COURT: no accessible route to the court. The concrete court has several cracks that must be sealed. The goals are not secure to the ground and must be reset in concrete foundations. Volleyball poles are not in compliance to PARD standards and need to be replaced with official volleyball poles.

Estimate cost \$7,530.00 (Equipment replacement and repairs)
