# ECHO LAKE PARK

## Park Assessment

August 28, 2016 (rev. March 2017)

In the past, the City of Fort Worth has been asked to assume maintenance and management of Echo Lake Park from Tarrant County. The purpose of this report is to provide an update on the letter issued on May 19, 2003 to City Manager Gary Jackson.

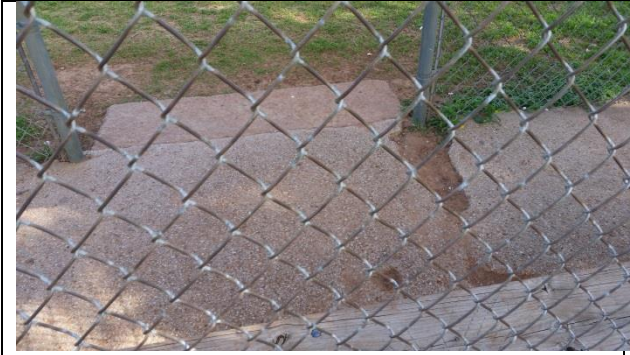
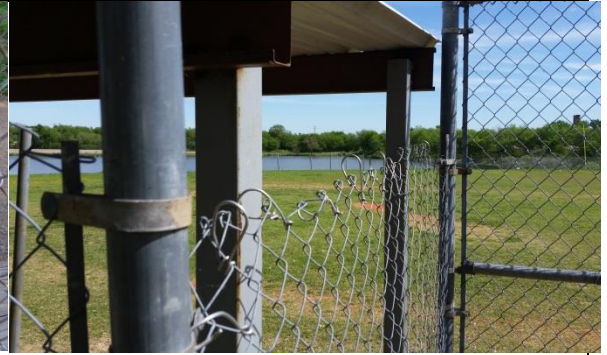
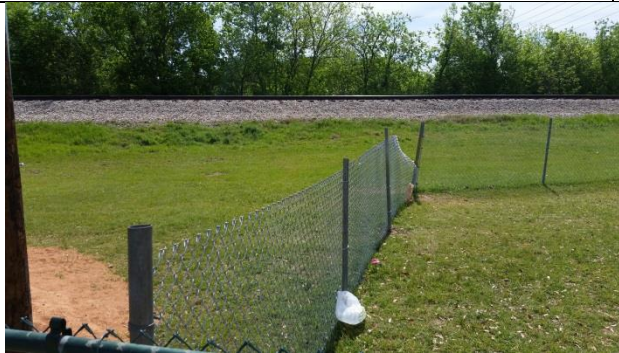
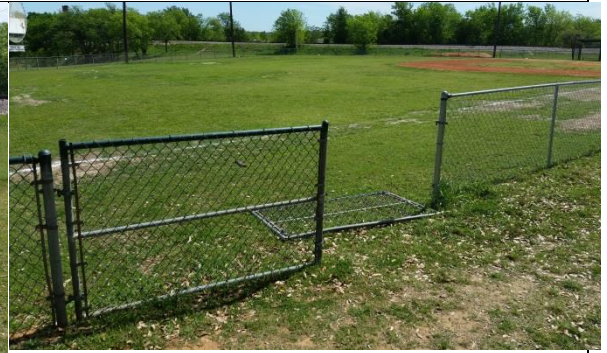
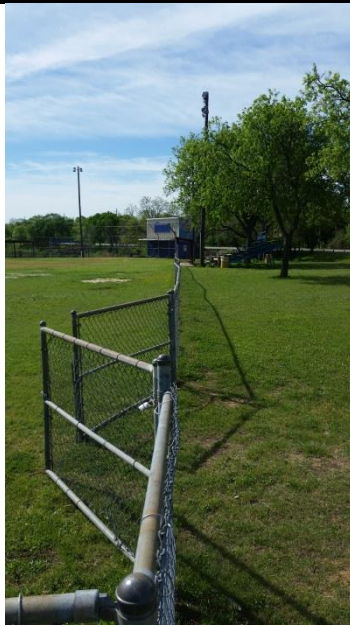
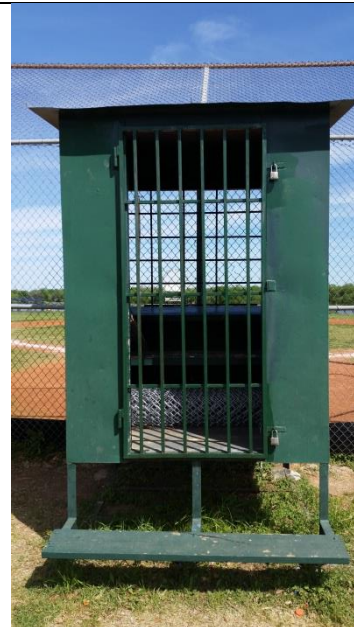
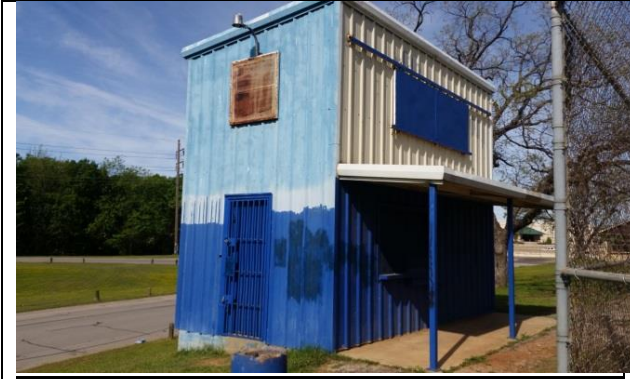
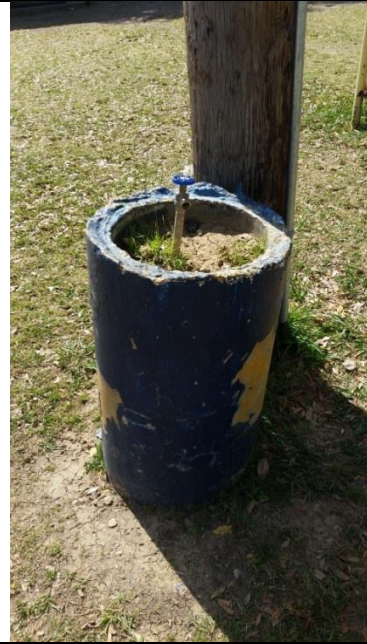
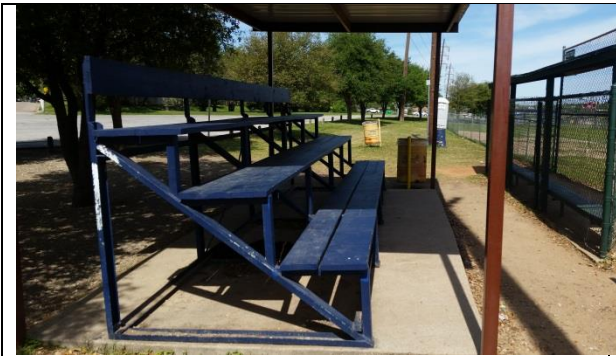
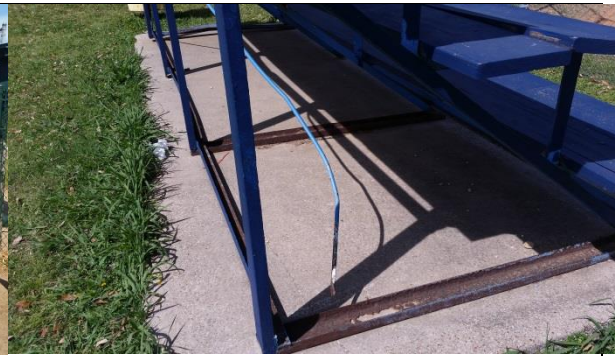
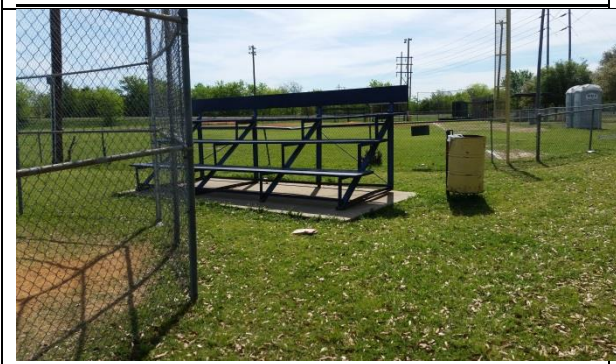
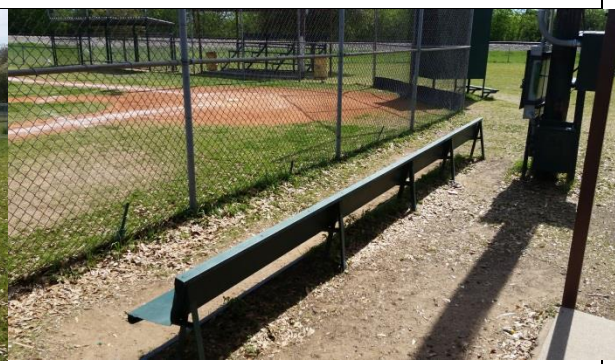
3. BALLFIELDS: Echo Lake Park has five ballfields. The four ballfields on the south side of the park are in poor condition. These fields are very small, close together, difficult to maintain, and they are not handicap accessible. Additionally, power line supporting poles are too close to the ballfield and are a hazard to the players. Only two of four scoreboards are functional (east and west). The remaining scoreboards are either vandalized or rusted. All wood frames in the dugouts need to be replaced or demolished. The entire ballfield fence needs to be upgraded or replaced. The foul poles need to be repaired or replaced. Drinking fountains are not PARD standard and they need to be replaced or removed from the site. Due to the amount of damage and danger surrounding all the ballfields they either need to be demolished or re-configured into non-competition fields. Bleachers do not meet ADA requirements. There is no clear accessible route to any of the bleachers.

Some of the existing frames are rusting or bent. The bleachers need to be removed and replaced.

Estimated cost: \$667,042.00 (Fencing 5 fields, rebuilt dugout at 5 fields, 2 Drinking Fountain, 2 Scoreboards, 2 irrigated fields, Concrete Sidewalk, 2 Competition fields with 3 practice fields, 12 Bleachers)
